Field Testing and Summary Report for Road 5 (Morris Road) Over Road 3 (Toftoy Throughway) at Redstone Arsenal, AL

Contractor's Supplemental Report for Project F09-AR16

**FIELD TESTING AND SUMMARY REPORT:
ROAD 5 (MORRIS RD) OVER ROAD 3 (TOFTOY
THWY) REDSTONE ARSENAL, AL**

April, 2010

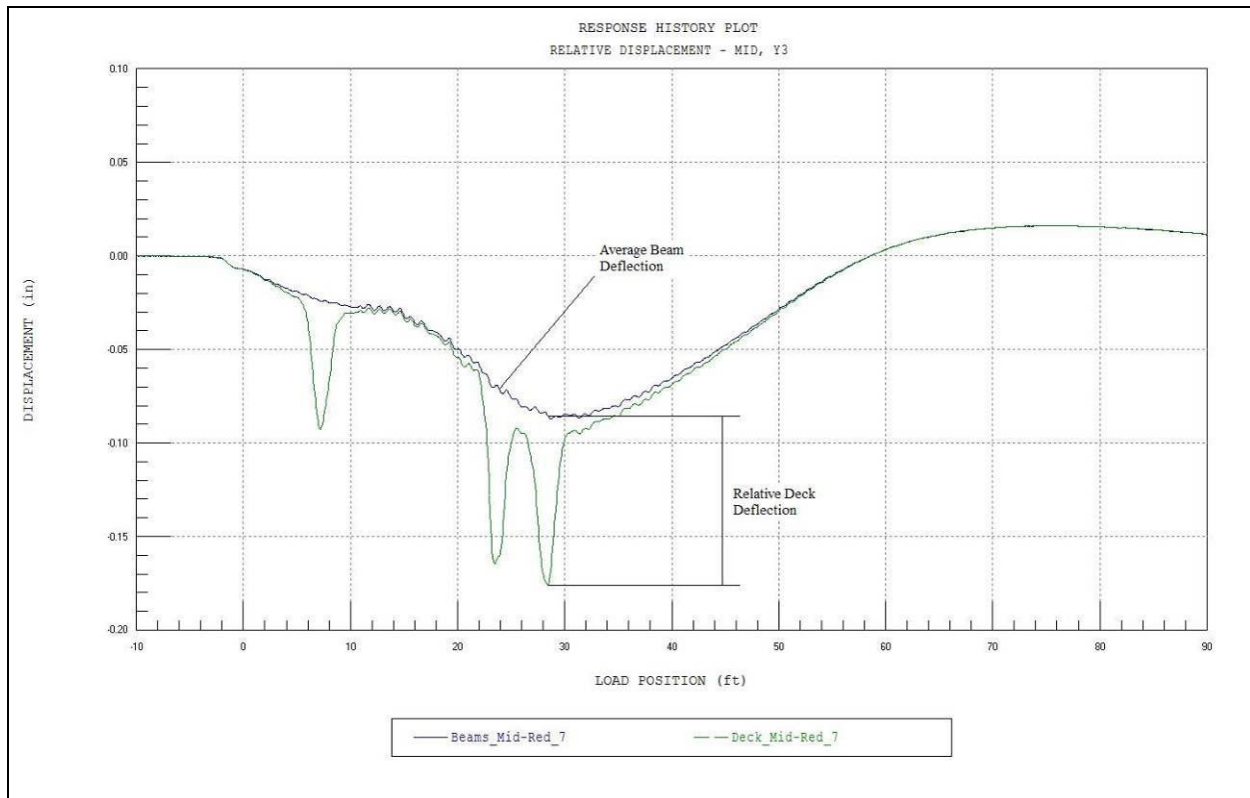
Figure 2.8 Deck deflection and average beam deflection at inner bay for Truck Path Y3.

- ***MIDSPAN FRP DECK DEFLECTIONS:*** Midspan deck deflections were measured at the same locations as the midspan deck strains: in the middle bay directly centered between the two interior beams, and in one side bay directly centered between an interior beam and the corresponding exterior beam. However, in order to isolate the relative deck deflection from the total bridge deflection (deck and beams), beam deflections were also measured. By subtracting the average of the two adjacent beam deflections from the total measured deflection at a given midspan deck location, the relative deflection of the deck itself was obtained. Figure 2.5 through Figure 2.8 shows the maximum total midspan deck deflection and respective average beam deflection for each truck path.

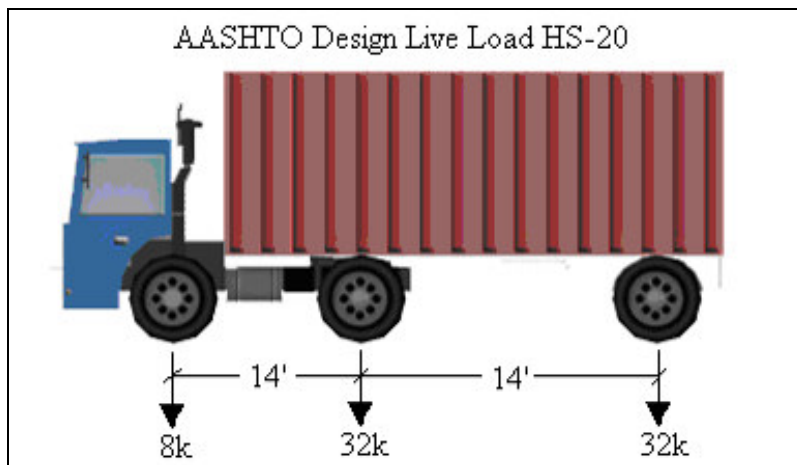
Figure 3.1 HS-20 vehicle configuration.

The result of this “backward” calculation showed that in order for the deck to fail the deflection criteria, the test truck’s rear axles would have weighed 25.3 kips and the front axle would have weighed 28.1 kips. This is a very unlikely distribution for a three-axle dump truck, which supports the conclusion that the deck met the design specification for deflection. For reference, Figure 3.1 shows the axle configuration and load distribution of an HS-20 loading vehicle.

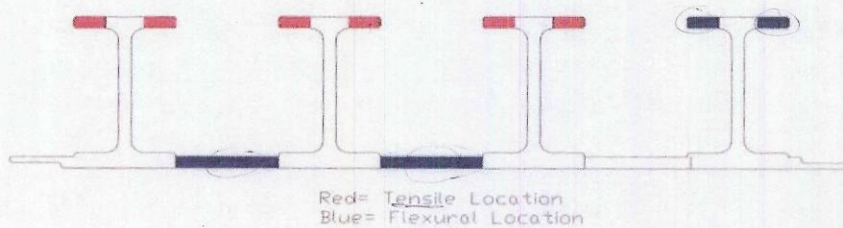
See Drawing below for sample location.

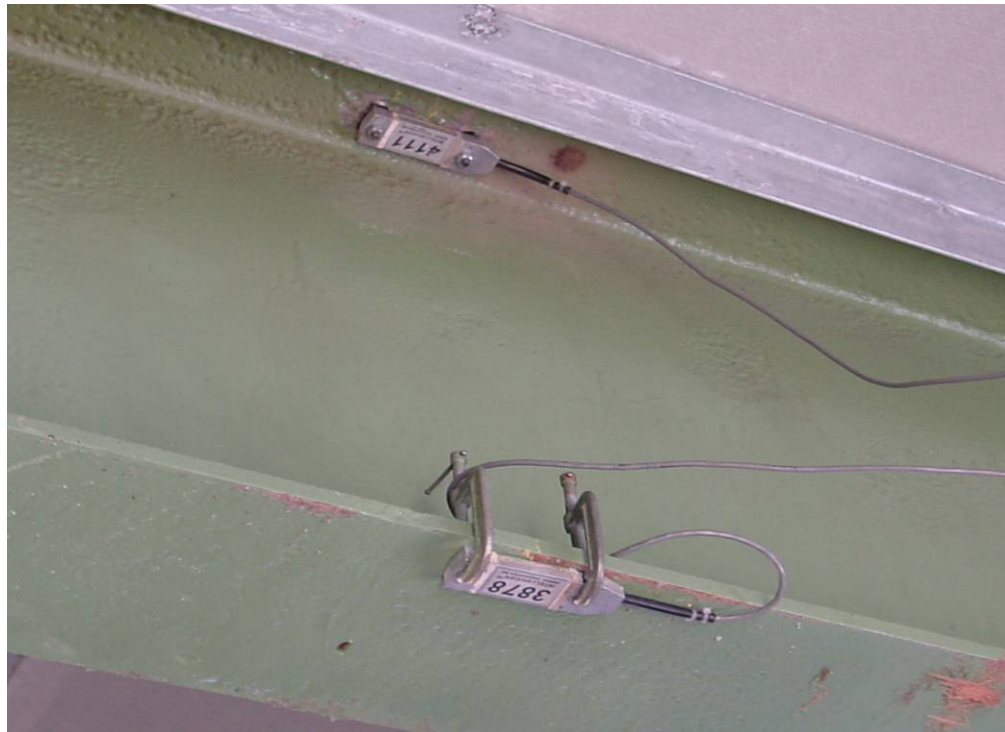
Figure C.1 Strain Transducers Mounted on Steel Girder

If the above steps are followed, it should be possible to mount each transducer in approximately five to ten minutes. The following figures illustrate transducers mounted on both steel and reinforced concrete members.

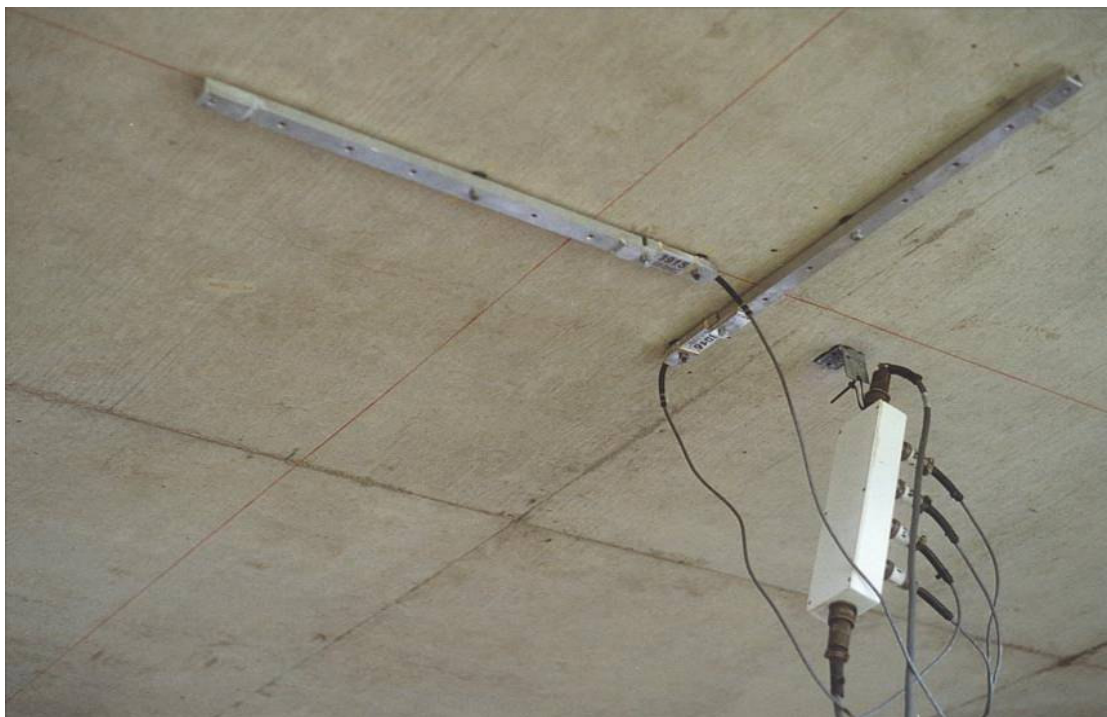
Figure C.2 Transducers w/Gage Extensions Mounted On R/C Slab

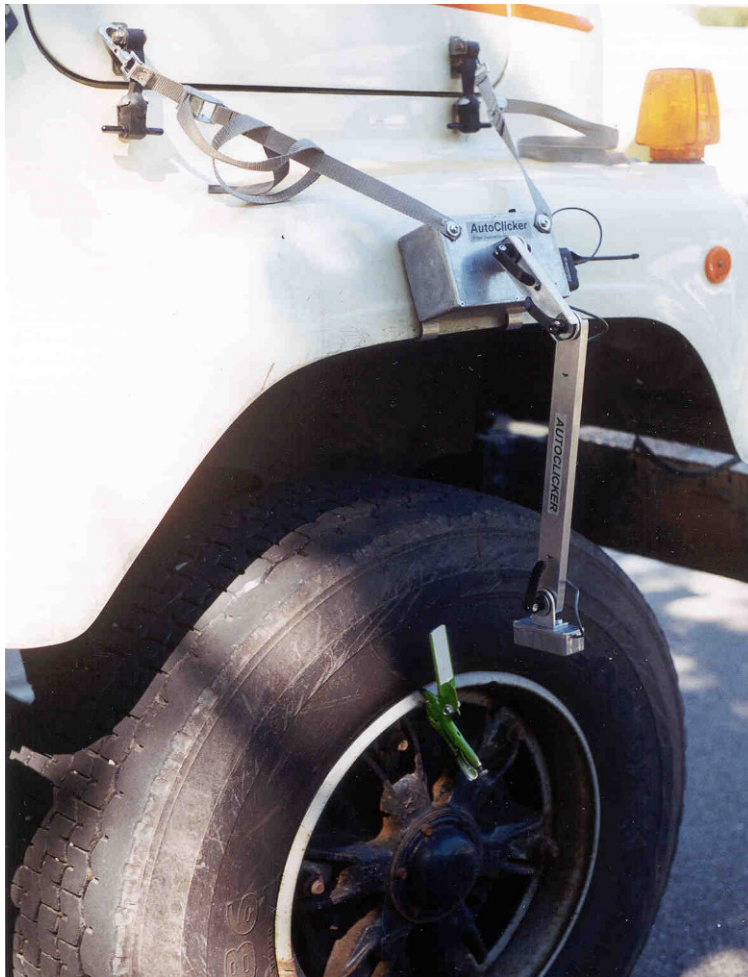
Figure C.3 AutoClicker Mounted on Test Vehicle

Once all of the STS units have been connected together, only one cable must be run and connected to the STS Power Supply located near the PC. Once power and communication cables are connected, the system is ready to acquire data. One last step entails installing the AutoClicker on the test vehicle as seen in Figure C.3.

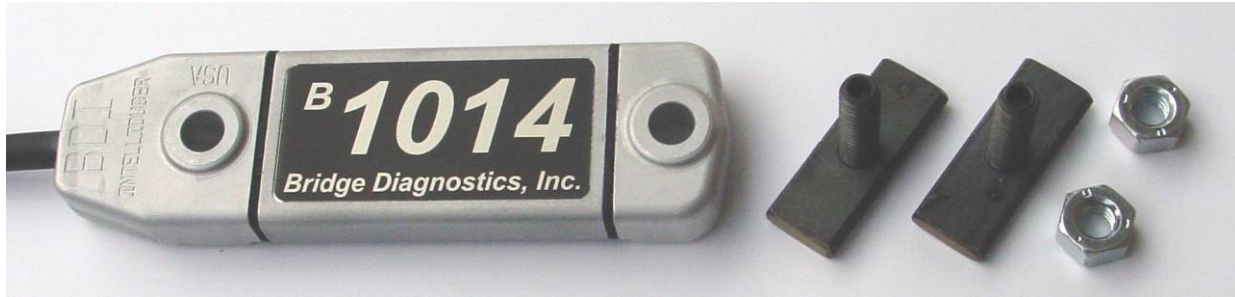
SPECIFICATIONS: BDI STRAIN TRANSDUCERS

Effective gage length:	3.0 in (76.2 mm). Extensions available for use on R/C structures.
Overall Size:	4.4 in x 1.2 in x 0.5 in (110 mm x 33 mm x 12 mm).
Cable Length:	10 ft (3 m) standard, any length available.
Material:	Aluminum
Circuit:	Full wheatstone bridge with four active 350Ω foil gages, 4-wire hookup.
Accuracy:	± 2%, individually calibrated to NIST standards.
Strain Range:	Approximately ±4000 µε.
Force req'd for 1000 µε:	Approximately 9 lbs. (40 N).
Sensitivity:	Approximately 500 µε/mV/V,
Weight:	Approximately 3 oz. (88 g),
Environmental:	Built-in protective cover, also water resistant.
Temperature Range:	-60°F to 250°F (-50°C to 120°C) operation range.
Cable:	BDI RC-187: 22 gage, two individually-shielded pairs w/drain.
Options:	Fully waterproofed, Heavy-duty cable, Special quick-lock connector.
Attachment Methods:	C-clamps or threaded mounting tabs & quick-setting adhesive.

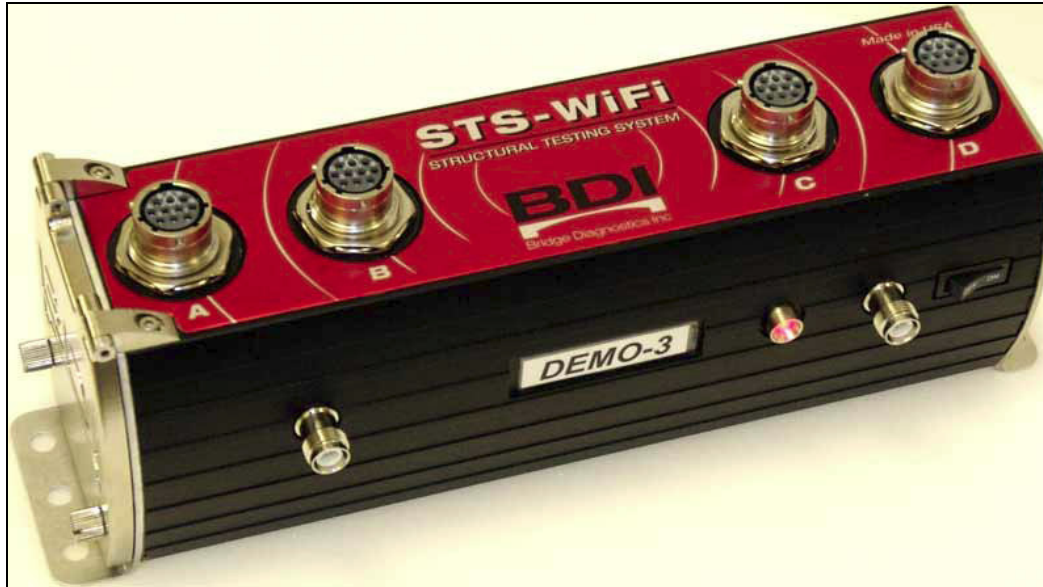
SPECIFICATIONS: BDI WIRELESS STRUCTURAL TESTING SYSTEM

Channels	4 to 128 (Expandable in multiples of 4)
Hardware Accuracy	$\pm 0.2\%$ (2% for Strain Transducers)
Sample Rates	0.1 – 500 Hz (Internal over-sampling rate is 19.5-312 kHz)
Max Test Lengths	21 minutes at 100 Hz. 128K samples per channel maximum test lengths
Gain Levels	1, 2, 4, 6, 16, 32, 64, 128
Digital Filter	Fixed by selected sample rate
Analog Filter	200 Hz, -3db, 3 rd order Bessel
Max. Input Voltage	10.5 Volts DC
Battery Power	9.6 NiMH rechargeable battery (Programmable low-power sleep mode)
Alternative Power	9-48 Volts DC input
Excitation Voltages	
Standard:	5 Volts DC
LVDT/Other:	5.5 Volts DC
A/D Resolution	0.3uV bit (24-bit ADC)
PC Requirements	Windows XP or higher
PC Interface	Wi-Fi Ethernet 802.11b: 10/100 Mbps
Auto Zeroing	Sensors automatically zero before each test
Enclosures	Aluminum splash resistant
Sensor Connections	All aluminum military grade, circular bayonet “snap” lock
Vehicle Tracking	BDI AutoClicker, switch closure detection

Sensors	BDI Intelliducer Strain Transducer Also supports, LVDT's, foil strain gages, accelerometers, Load Cell's and other various DC output sensors Single RS232 serially-interfaced sensor
On-Board PC	
Processor:	520 MHz Intel XScale PXA270
RAM:	64MB
Dimensions	
Base Station:	10" x 6" x 4"
STS 4-Channel Node:	11" x 3.5" x 3.23"

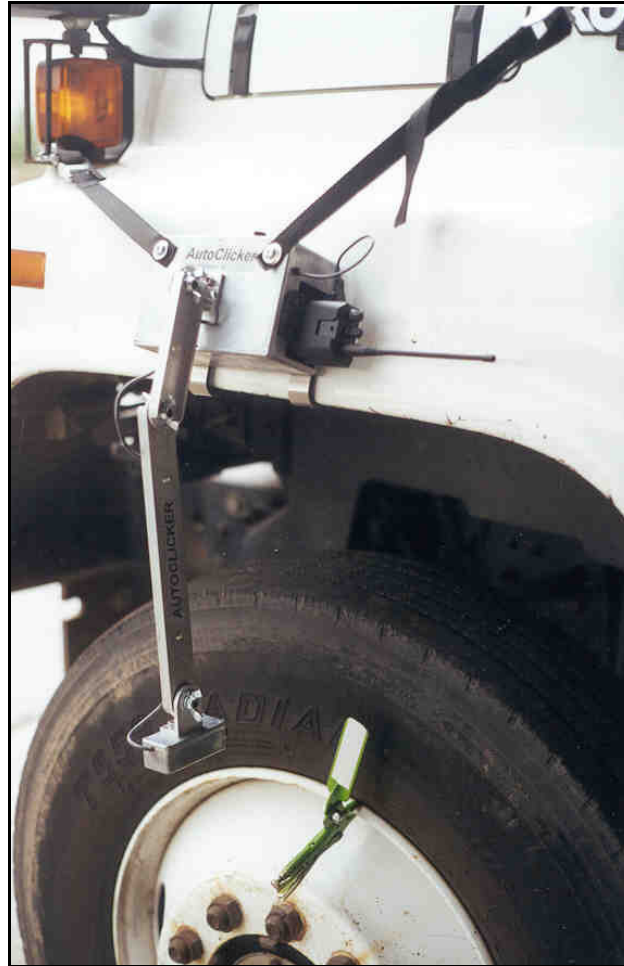
SPECIFICATIONS: BDI AUTOCLICKER

3 Handheld Radios	Motorola P1225 2-Channel (or equal) modified for both “Rx” and “Tx”.
Power	9V battery
Mounting	Universal front fender mounting system
Target	Retroreflective tape mounted on universal wheel clamp
Bands/Power	VHF/1 Watt or UHF/2 Watt
Frequencies	User-specified
Data Acquisition System Requirements	TTL/CMOS input (pull-up resistor to 5V)
Output	Isolated contact closure (200V 0.5A max switch current)
